THESIS

AN INVESTIGATION INTO THE COMPARISONS OF THE UNDERWATER SHOCK EFFECTS ON A STIFFENED FLAT PLATE TO THE PREDICTIVE NATURE OF A COMPUTER MODEL

John R. Langan

March 1985

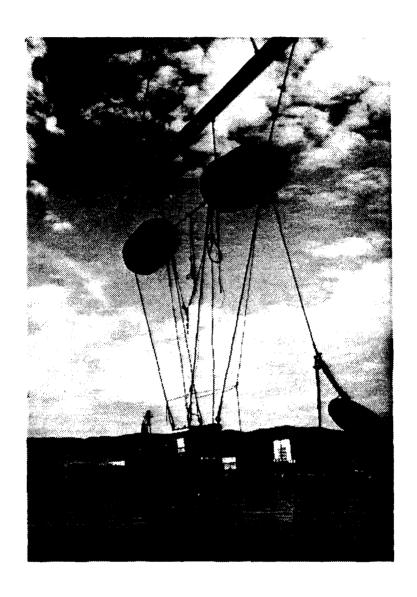
Figure 4.7 Test Structure After First Explosion

The plate surface was carefully inspected with no visible damages noted. Deflection measurements were not taken as a micrometer was not available. The electrical connection box remained water-tight and all but one of the sensors were still operational. After a short deliberation and determining the availability of another eight-pound charge, it was decided to fire another shot later that same day. WCSF

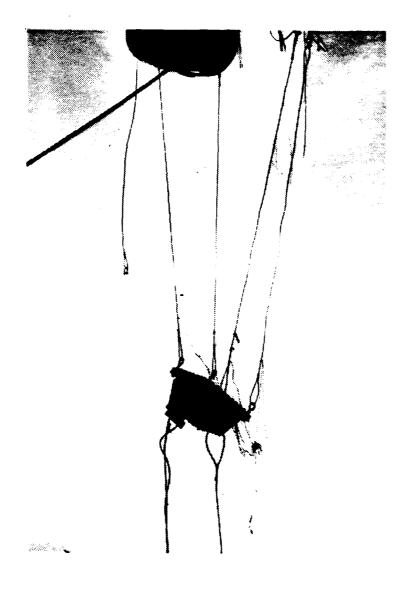
Figure 4.11 Post Shot View of Test Rig

Approximately three hours later, another explosion occurred. This time two blasting caps were used to ensure full detonation of the TNT. It was apparent from the noise and water plume that the second shot was significantly larger than the early one. It was later determined from pressure data graphs that the peak pressure pulse experienced by the plate for this second shot was 4217 psi, which is equivalent to a 9.84 pound TNT charge. Figure 4.9 shows the water plume produced by the second shot. One of the pneumatic bladders ruptured from the force of the explosion, as shown in Figure 4.10. Another post shot view, Figure 4.11, shows the damage experienced by the test rig. Notice how two of the test platform support cables have been torn free.

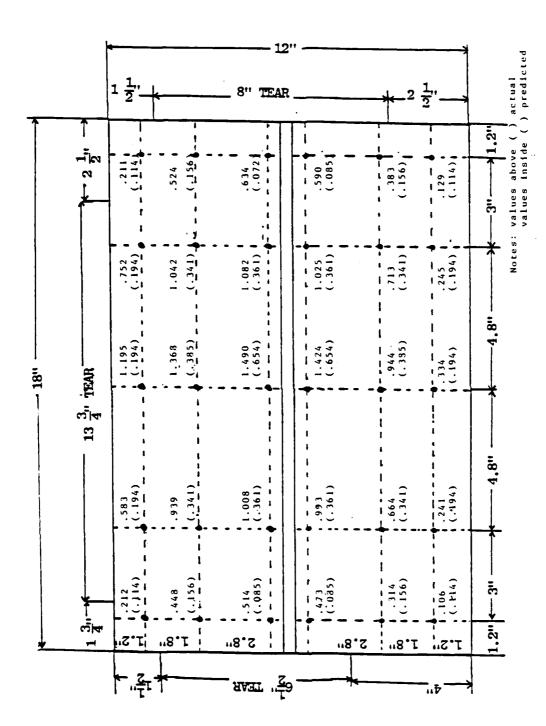
Figure 5.2 Large Plate Tear at the Side

As mentioned in Chapter IV, the first shot did not produce any noticeable physical results. However, the second shot did achieve large deformations as evidenced by Figures 5.1 and 5.2. Both stiffener's ends sheared and there are tears along three of the sides. The exact tear lengths are recorded on Figure 5.3. Not visible in any of the photos is the fact that several strain gages became detached from the plate surface during the testing. Additionally, a few of the strain gage lead wires were severed. This severing was probably due to a guide wire shackle that parted from the ruptured flotation device following the shot.

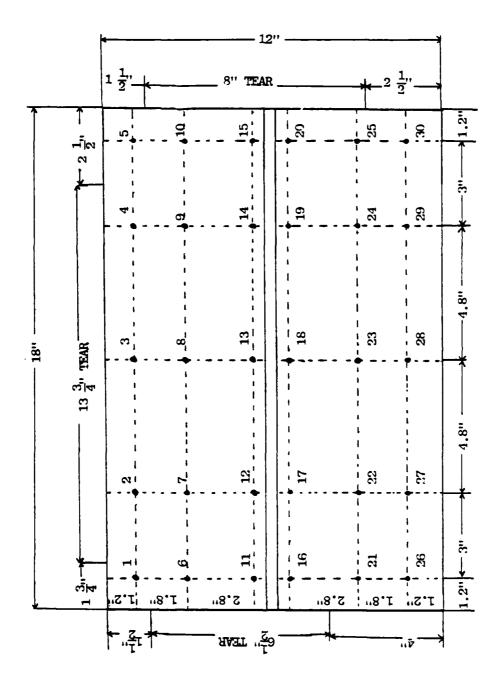
Figure 5.5 Deflection Locations

to the shearing of both ends of the stiffener. Numerical analysis does not predict the shearing or tearing along the sides. From the data, the sequence of fractures is not discernible. Knowing the order of fracture occurrence would give a better clue to plate responses. Additionally, EPSA predictions do not accurately forecast experimental results. In general the code predictions are lower than measured.

To observe stiffener tripping, the stiffener needs to have a compression mode throughout its entire length. Curvature must be introduced to the test panel. It is recommended for future studies to perform UNDEX testing using a stiffened shell model. This would provide all-around compression on the stiffener, promoting stiffener tripping instead of shearing. Also, it is necessary to incorporate tearing effects or fracture mechanics into the numerical analysis scheme. Symmetry loading conditions are not always observed from an UNDEX experiment and these need to be taken into account.
